Water tank life extension solution
[SUS coating] proposal

No update water tank required
Direct application without primer
Base material protection with stainless steel (SUS316L)

FRP tank Upgrade – Stronger and like New!

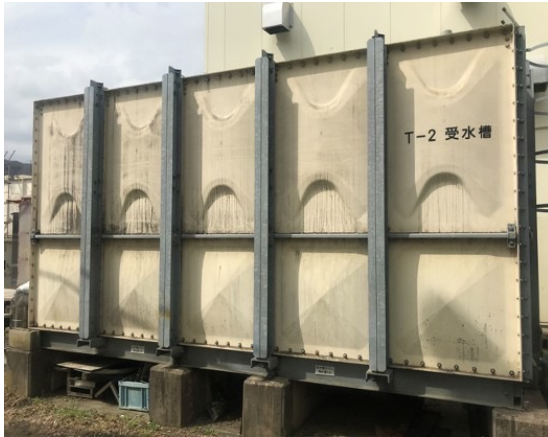
Before
Application

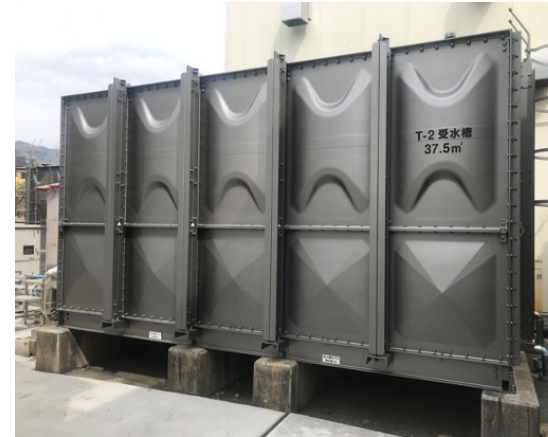
After
Application

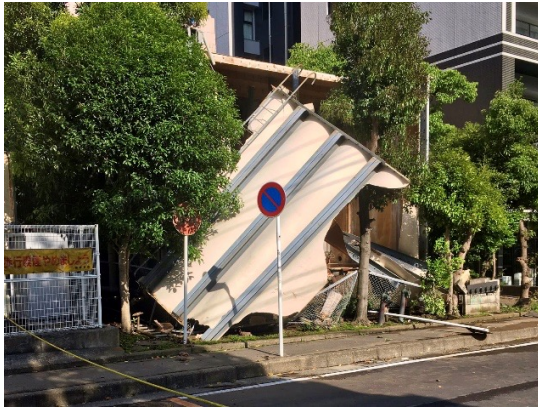
Bursting accident due to aging deterioration

In 2020, an accident occurred at a commercial water storage facility when the tank burst because it could not withstand the water pressure inside.

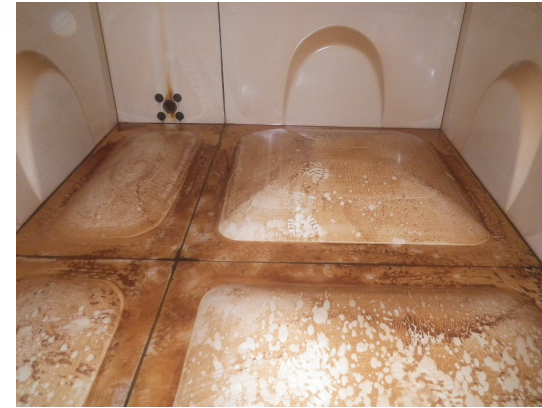
internal stains

FRP deteriorates after about 10 years and sunlight passes through it, causing the growth of bacteria through photosynthesis.

Even if the interior is cleaned once a year, it often returns to the same condition six months later, and dirt and bacteria are mixed in.

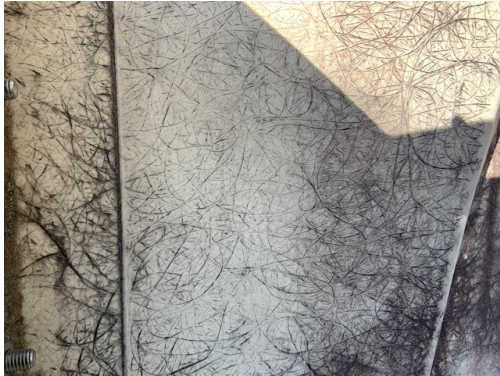
exposed glass fiber

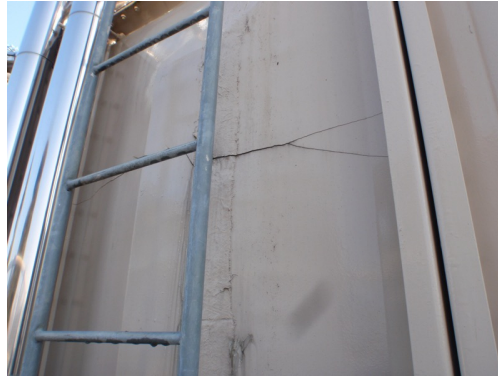
panel cracks

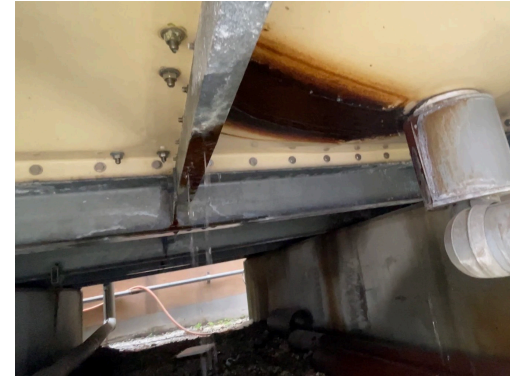
water leak

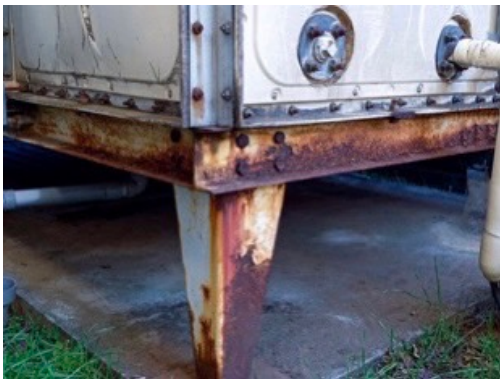
Rust on the frame

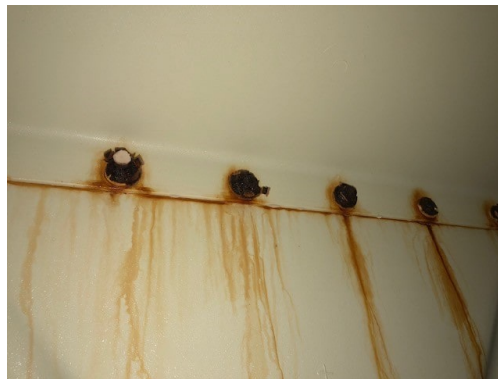
internal rust

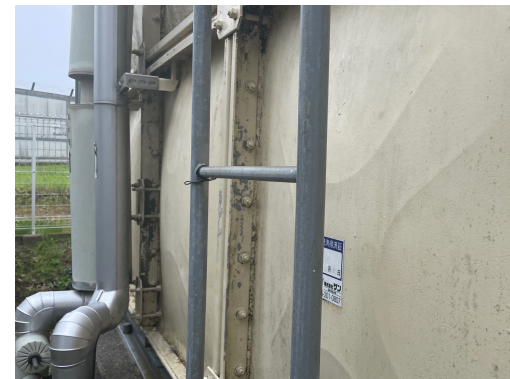
Paint peeling

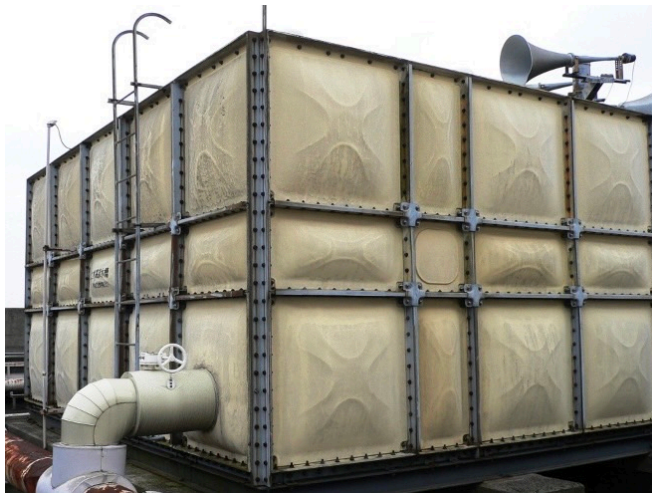
Before coating application
(FRP elevated water tank)

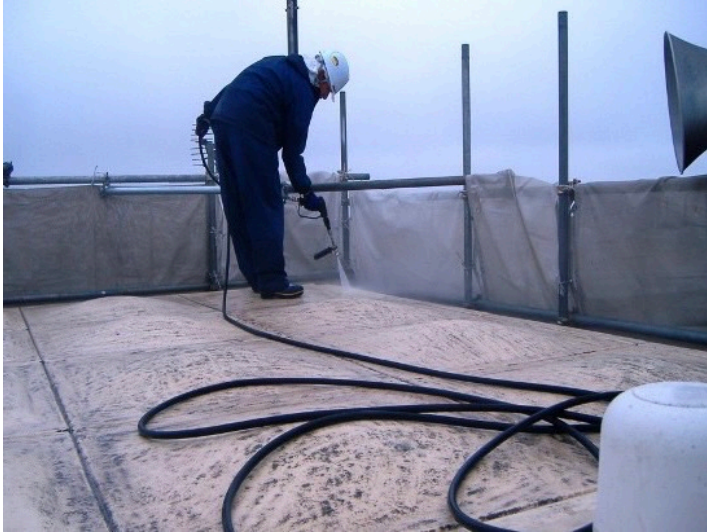
(1) Base preparation (high pressure washing/cleaning)

If high-pressure water cleaning is not possible, use a brush or scraper to remove dirt from the FRP body.

The trestle and steel frame parts are removed with a wire brush to remove rust and old paint.

Finish by removing old paint, rust, and aged old coatings with an electric brush.

If algae is adhering to the surface, wash with water and dry thoroughly using a blower.

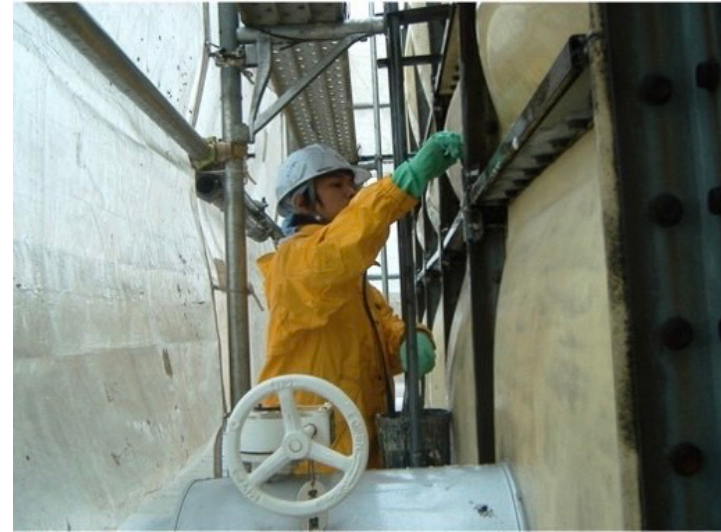
(2) Base de-greasing treatment

Degrease the FRP body, dry it after degreasing, and wipe off any dust.

Corners and bolt attachment areas should be degreased thoroughly.

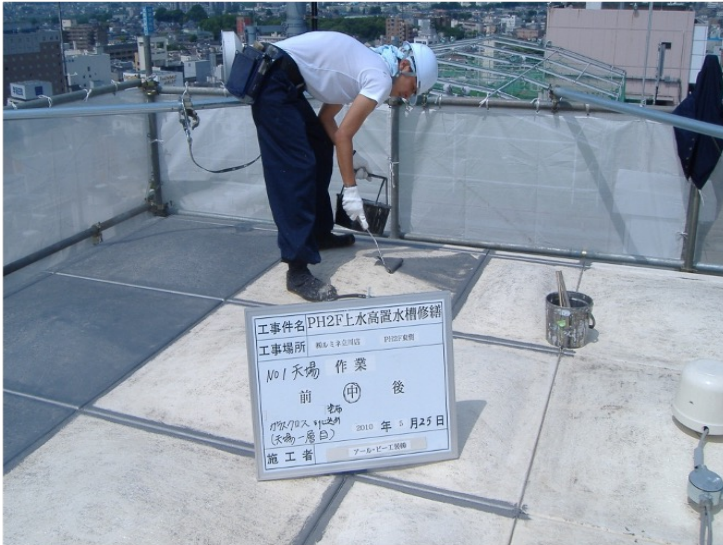
(3) Coating

Caulking is applied to the joints at the top edge to prevent rainwater contamination.

To firmly adhere the glass fibers of the FRP body, the top edge is painted 4 times, and the sides, bottom, base, and attached parts are painted 3 times.

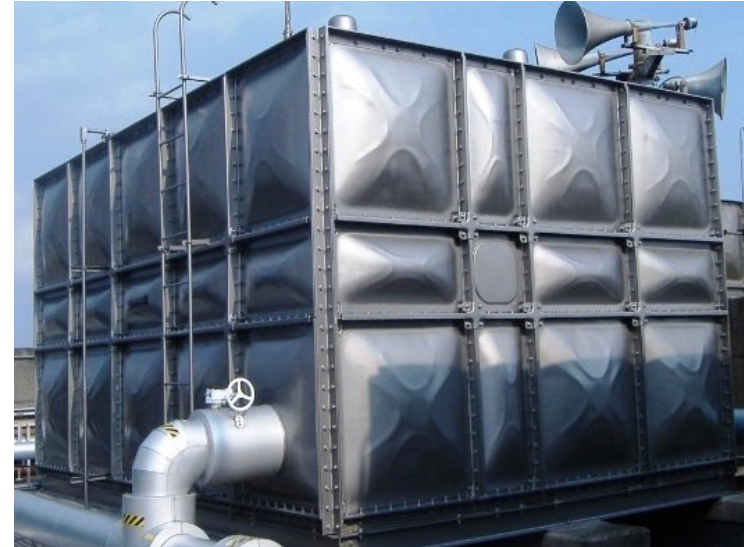
(4) Complete

Visually inspect the exterior to ensure that there are no uneven coatings or cracks on the outside of the tank.

*Yellowing may occur after installation, but this does not affect the protection of the base material.
